**NOTE: This is a copy of an appraisal that was done for the owner of this 1970 Oldsmobile. All contact information has been removed by the appraiser.**

Vehicle Make: **Oldsmobile** Model:**442** Year:**1970** VIN:

**Comments – Photos – Description**

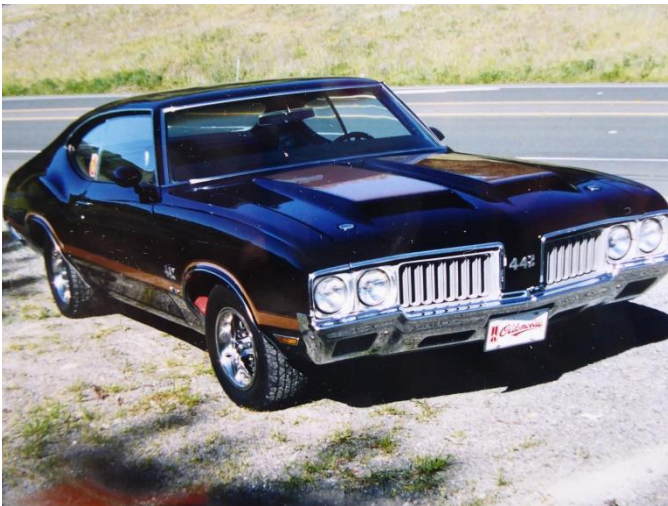
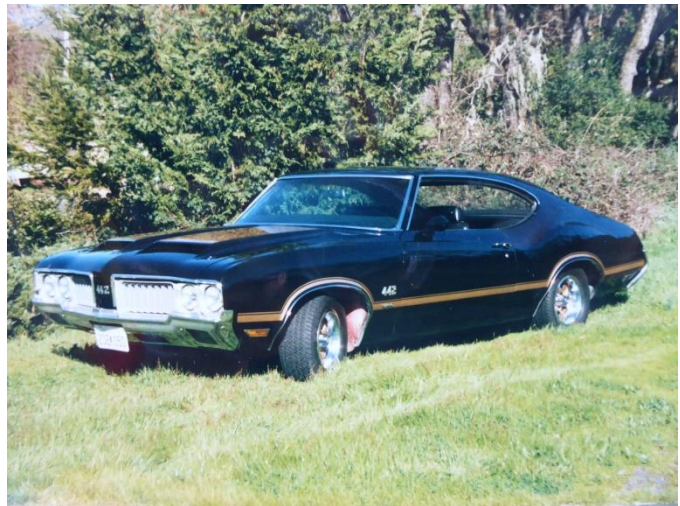
This 1970 Oldsmobile 442 has been restored to a very high quality “driver” and has participated in one of the Hot Rod Power Tours, which certainly tells how dependable it is for long road trips.

These photos were supplied by the owner. This appraiser states: these photos represent the current condition of the car.

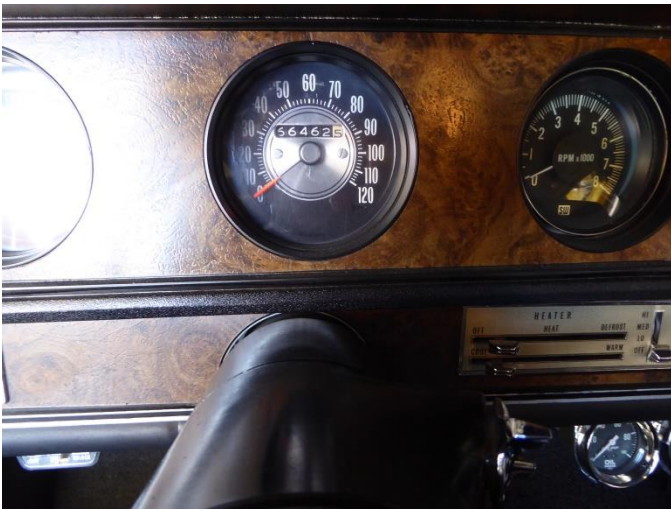
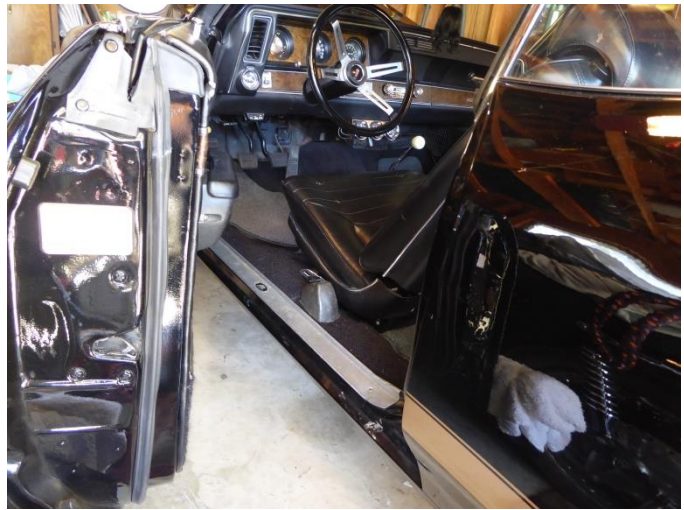
Rubber weather strips are all new reproduction. Many records and receipts are available to see where parts were sourced and what has been done during the restoration that was done in the late 1990's. NOTE: the paint is very glossy and picks up reflections of items near the car.

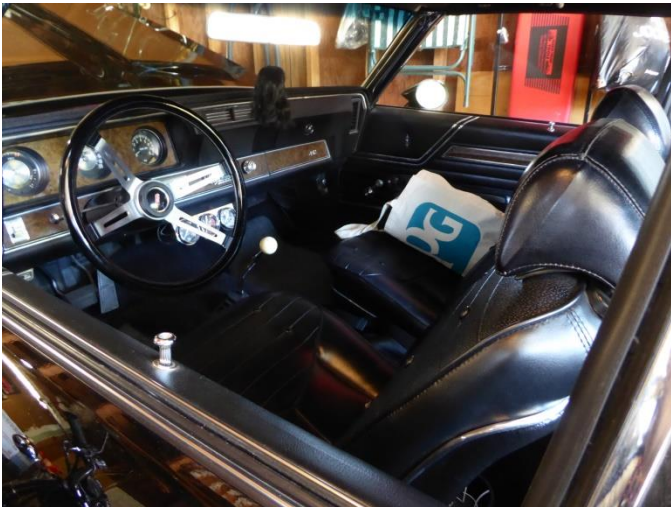
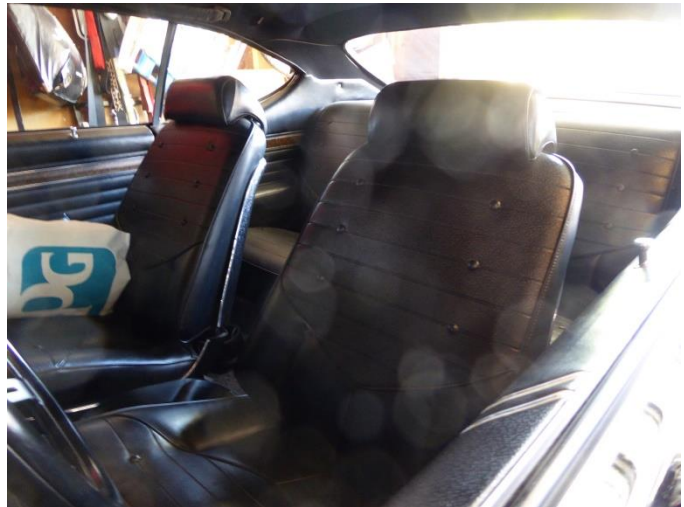
Interior is restored using correct materials from well-known suppliers. Original gauges work as do the aftermarket gauges below dash.

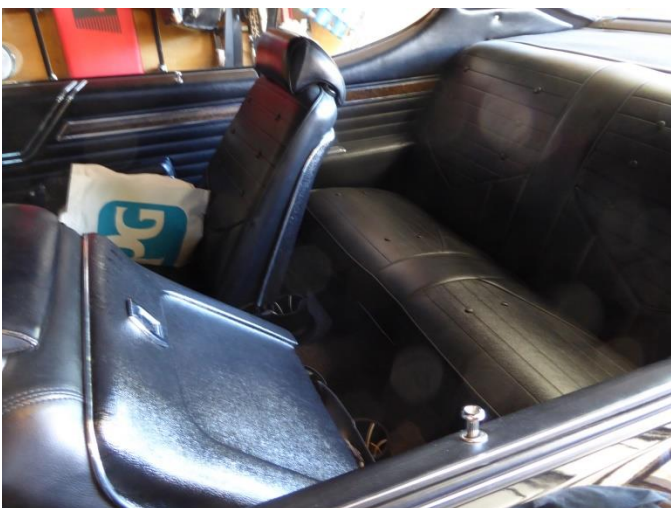
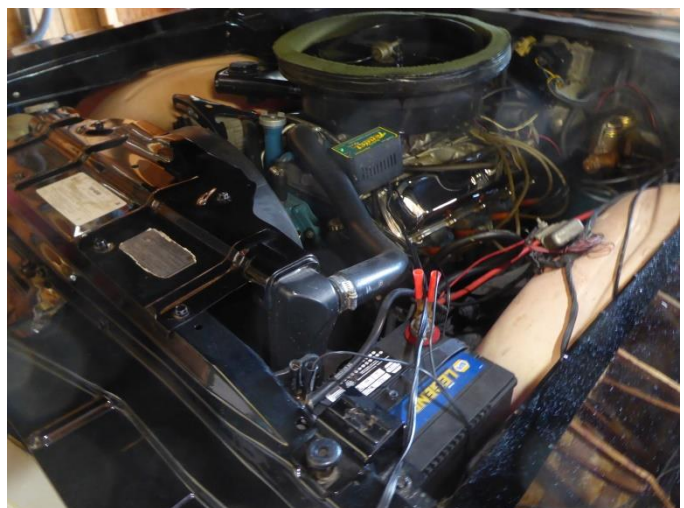
Upholstery is all very good and mostly replacement. This is a manual 4-speed car original 442 that has added W-30 items. The car is may not be a "matching number" 442 but is a real 442 with W-30 items added. This is not a W-30 442.

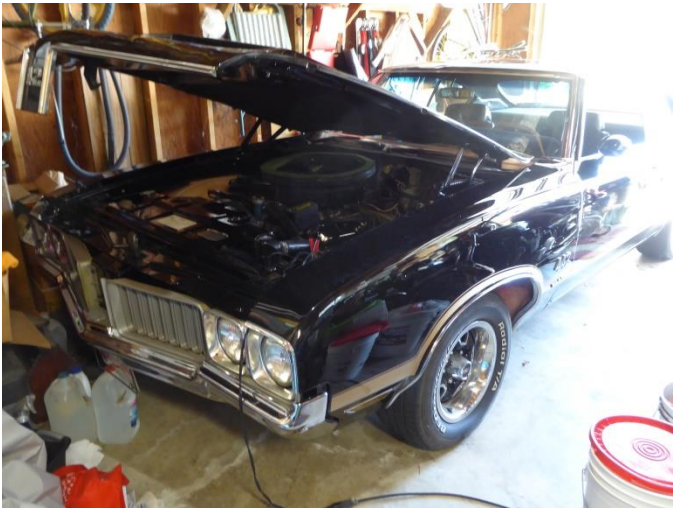
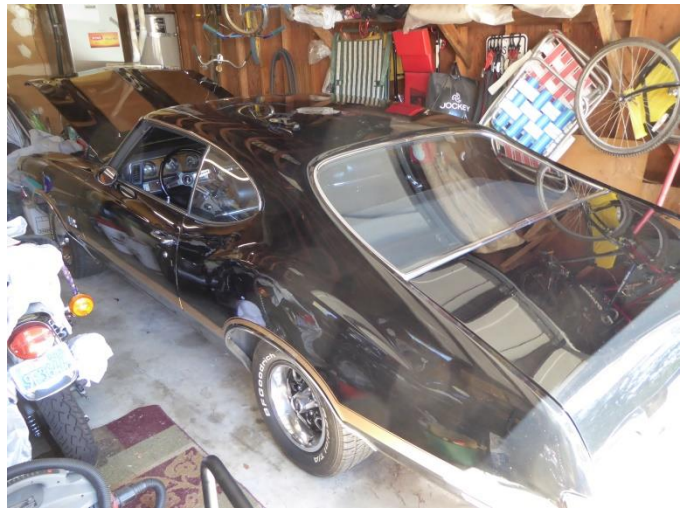
The body panels are excellent. All exterior trim is very good. The car has been judged at Oldsmobile meets and judging score sheets are available in the records. Panel fit is very good. Doors, hood and trunk open and close as expected. Glass is very good. Correct W-30 Ram Air hood with fiberglass top and steel base.

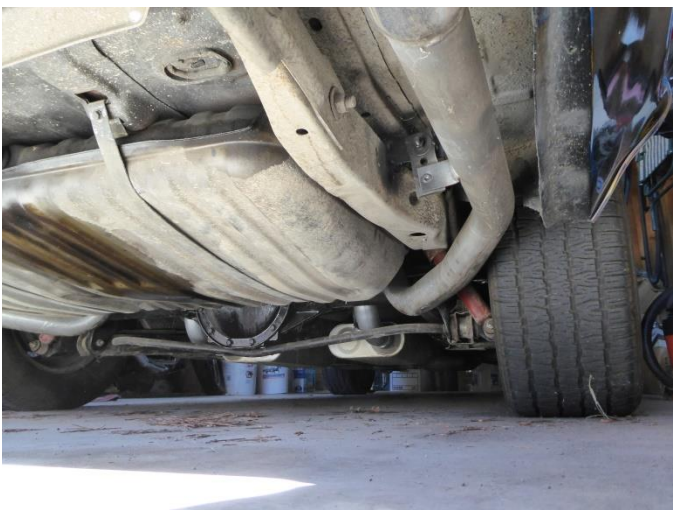
Gas tank has a stain that may need to be looked at. Exhaust looks very good with heavy duty "turbo mufflers". Grill and front trim are very good.

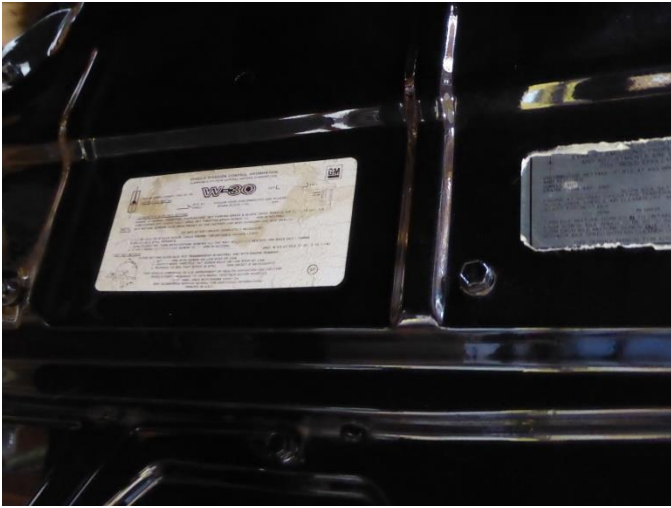
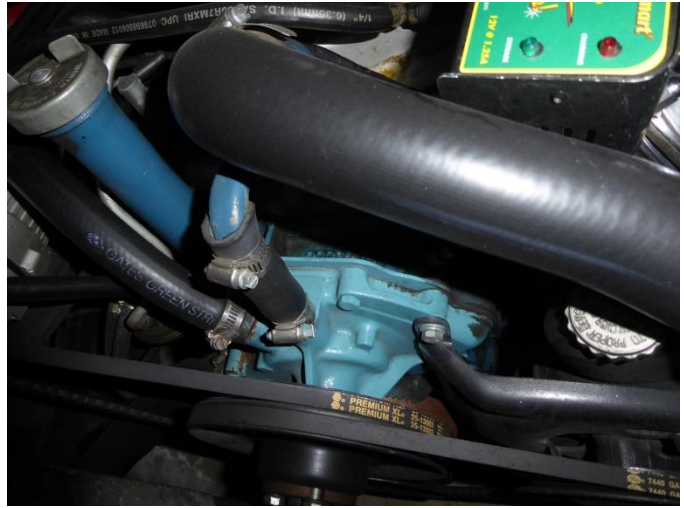
Engine has been rebuilt. All records are available. Engine has an Isky 270 camshaft and notes state .030 overbore with new pistons.

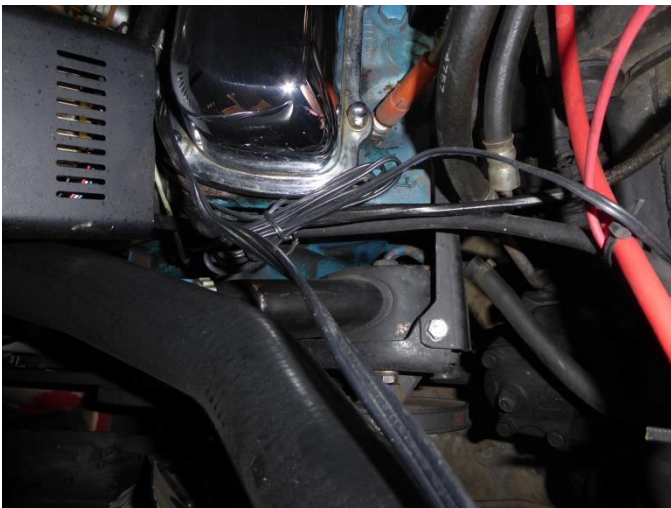
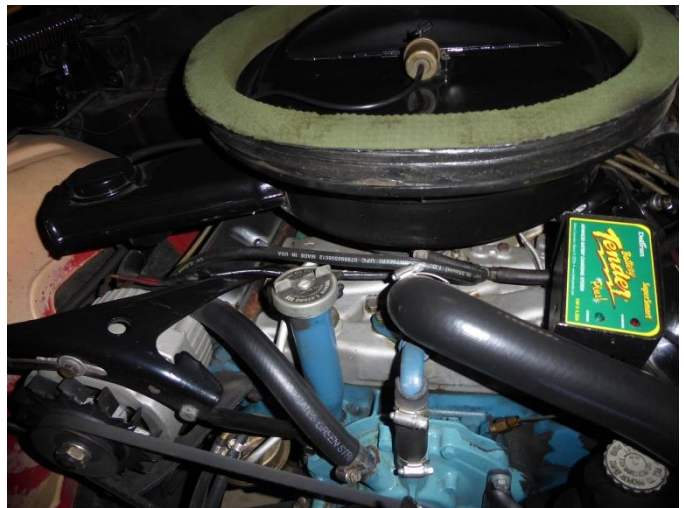
Engine compartment is clean and looks very good after several years since the restoration. Battery tender keeps the battery fresh. This appraiser started the engine and ran it for a short time. It easily started, had very good oil pressure and idled smooth. Transmission was shifted slowly into gear. Clutch adjustment was very good. Park brake worked as expected. Engine was not ran long enough to check for operating temperature stabilization.

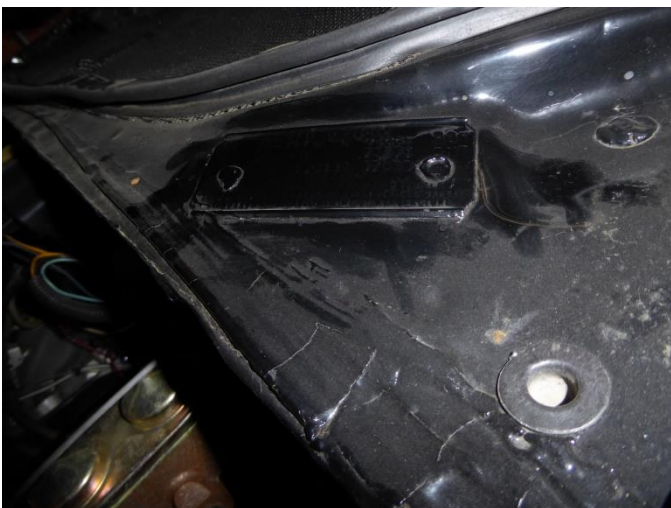
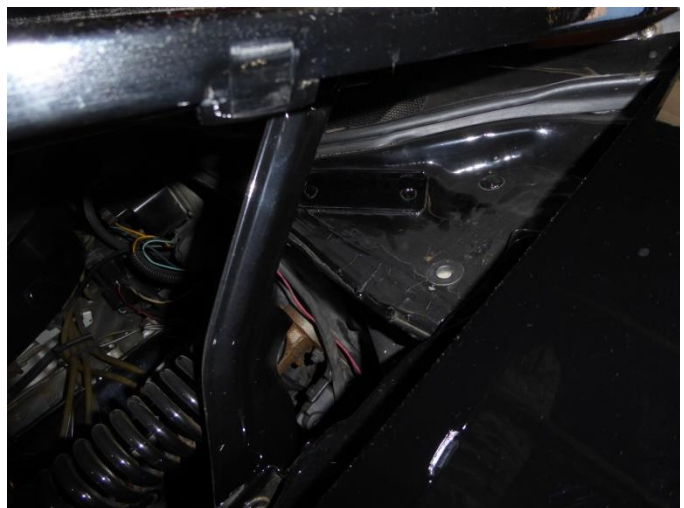
Factory body plate is in place Appears to be intact and not tampered with. This appraisal does not include data plate interpretation.

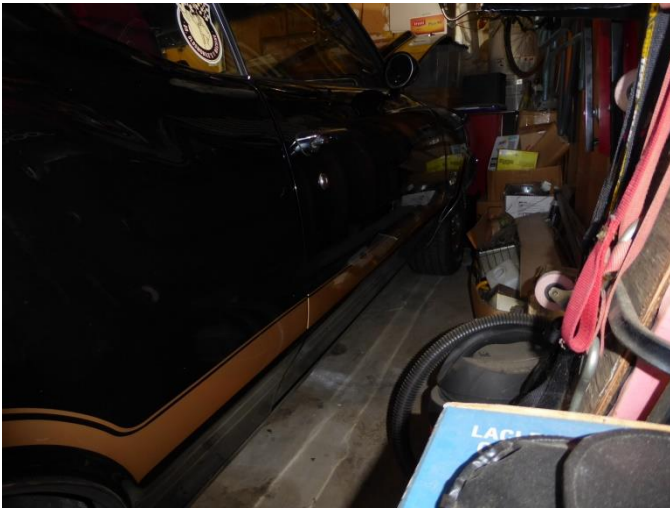
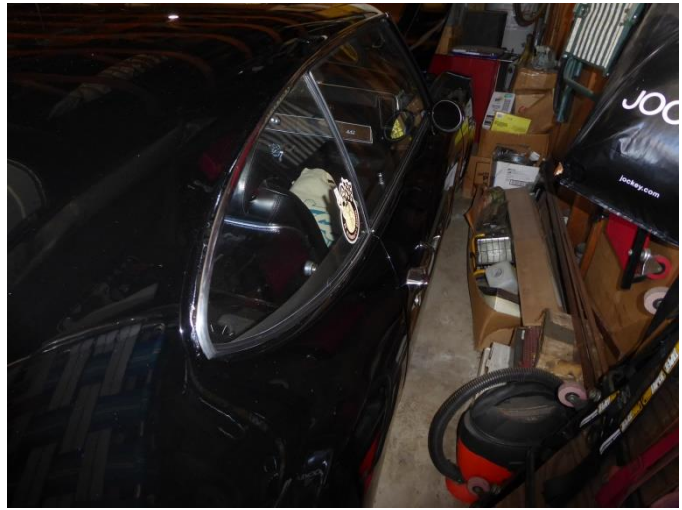
Right side of the car was not easy to get photos, however, this appraiser inspected the side and found it to be in very good condition.

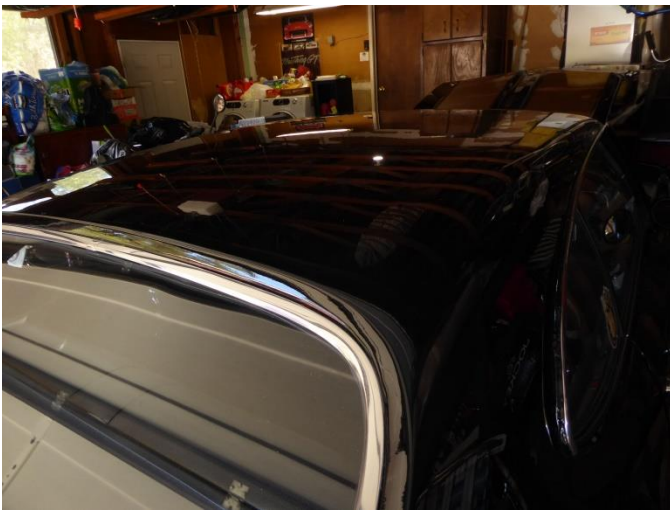
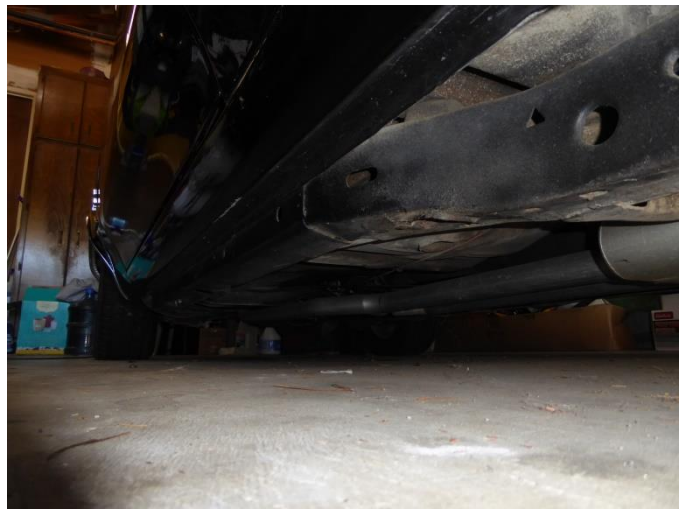
Roof looks very good. Windows closed and fit very good. Chassis is not restored, but is clean and sheet-metal appears to be in very good condition.

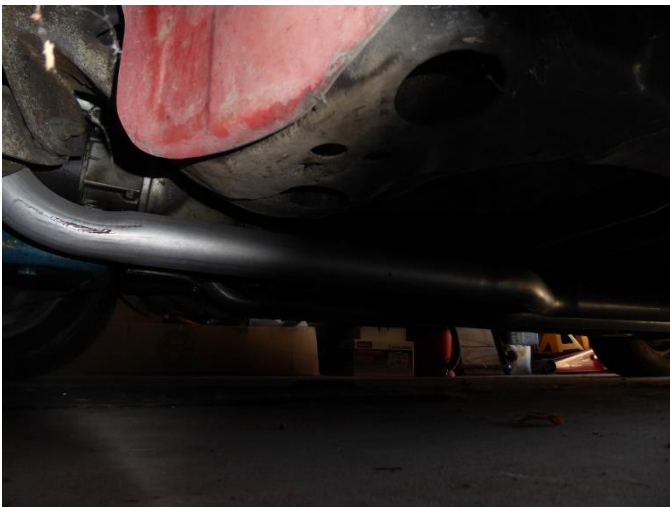
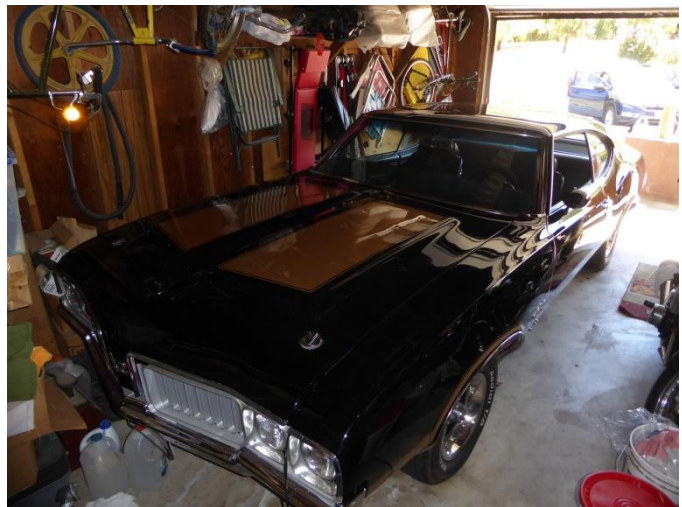
Wheel wells and chassis are very good- Not "detailed". Front leading edge of hood has some paint chips. Very difficult to see the chips in these photos. Paint overall is very glossy and smooth. Note the red inner fender wells, these are molded fiberglass parts that were standards on the W-30 cars.

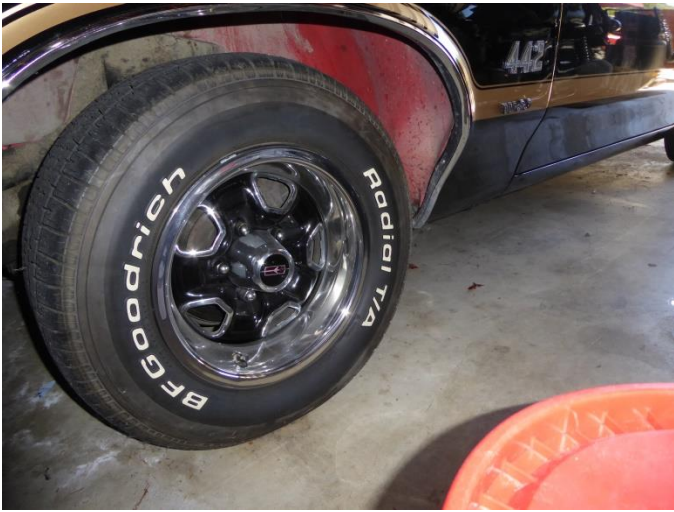
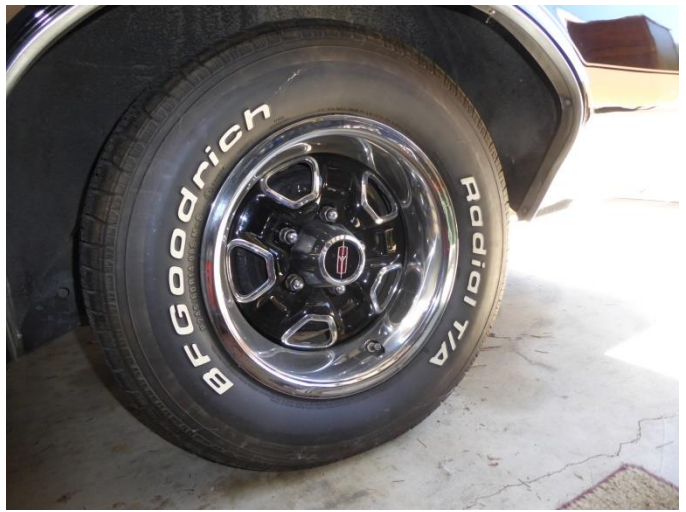
Radial T/A's all around on correct Olds rally wheels. All trim rings, caps and wheel hardware are very good. Notice the read fiberglass inner fender aprons. These are a W-30 feature. This car has enough of the W-30 items that it does a great job of representing the W-30 optioned 442.

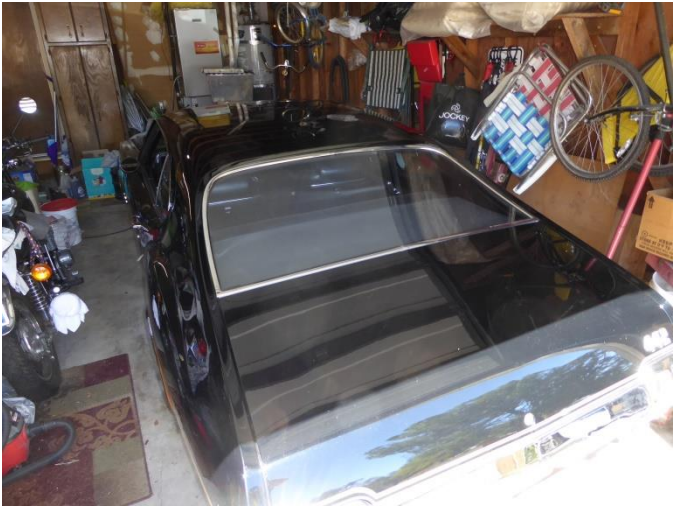
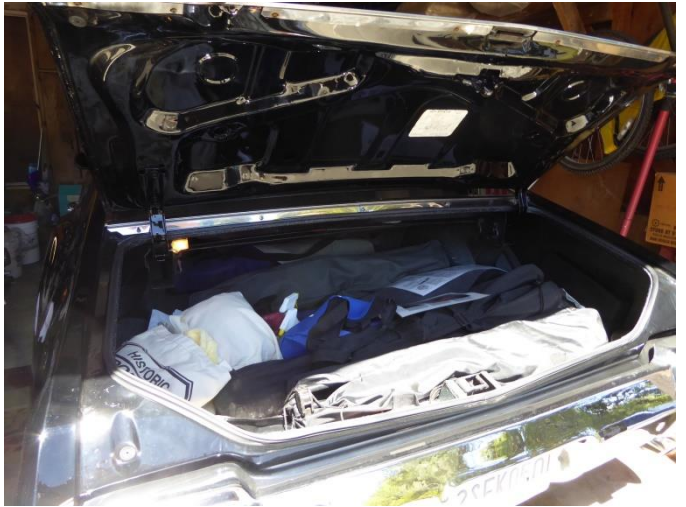
Trunk area had been restored with the original style trunk "splatter paint". All visible areas are restored as original.

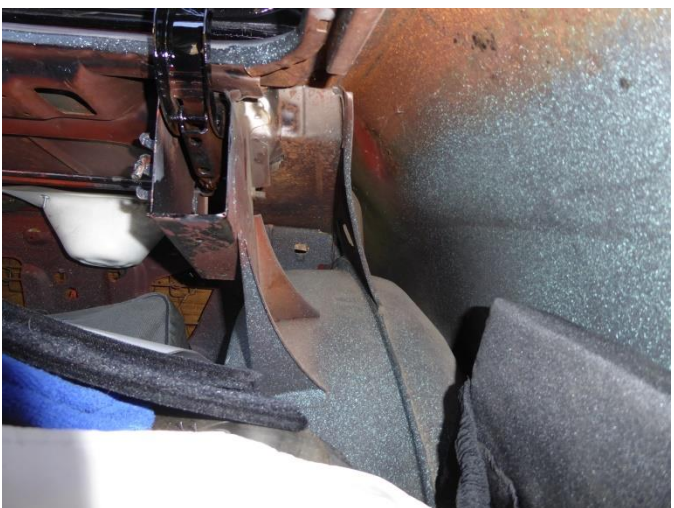
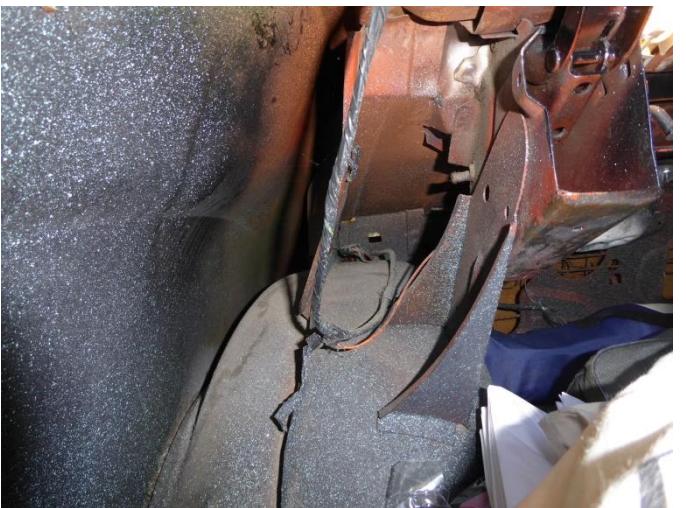
Leather These photos are shared so some view of the inner "back-side" of rear panels can be seen. These areas show the bottom area of the rear window that on some cars will show rust repairs. This car appears to have no issues or repair and is in very goods condition.
